Manuscript Report Number

372

ELEMENTS OF A MILITARY HERITAGE:
A STRUCTURAL HISTORY OF THE MERRICKVILLE
AND NEWBORO BLOCKHOUSES, THE JONES FALLS
AND WHITEFISH GUARDHOUSES, AND THE JONES
FALLS DEFENSIBLE LOCKMASTER'S HOUSE
by William Wylie
1980

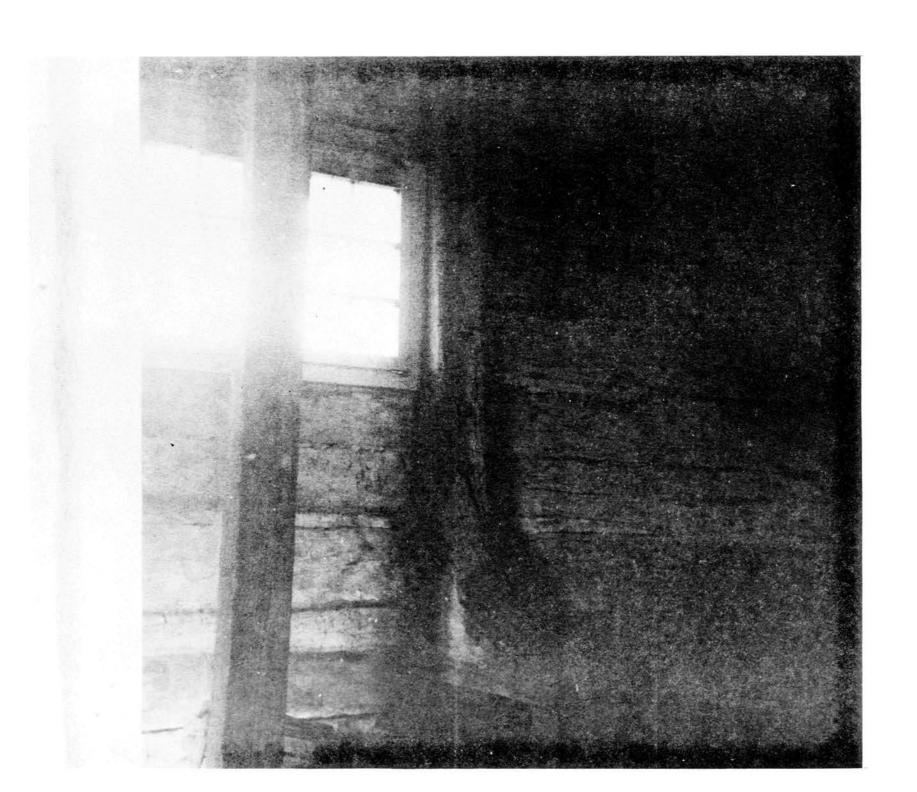
13 The Interior of the Merrickville Blockhouse, 1961, showing the temporary block under a knee brace and a new supporting post.

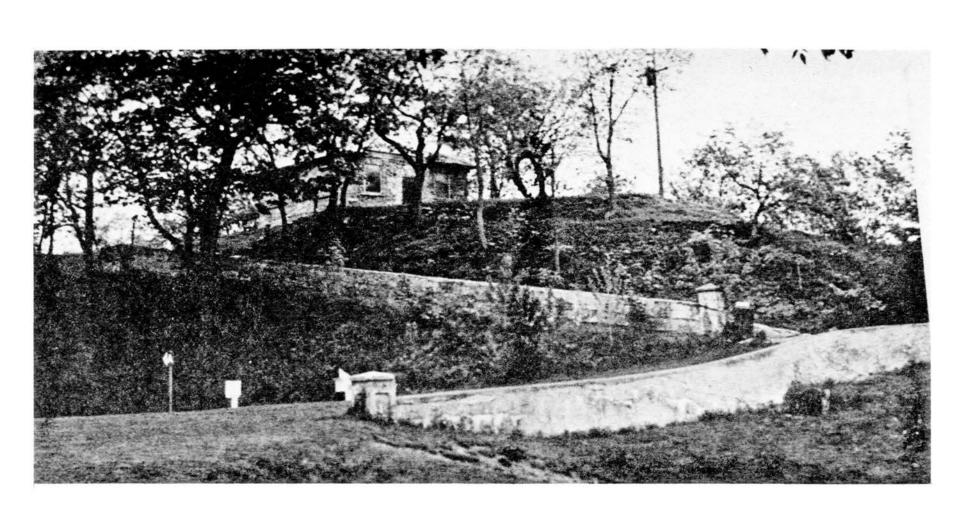
43 Concrete retaining walls on the approaches to the Jones Falls Lockmaster's House, 1973.
